Waterproofing Systems

Horizontal barriers against rising damp in masonry

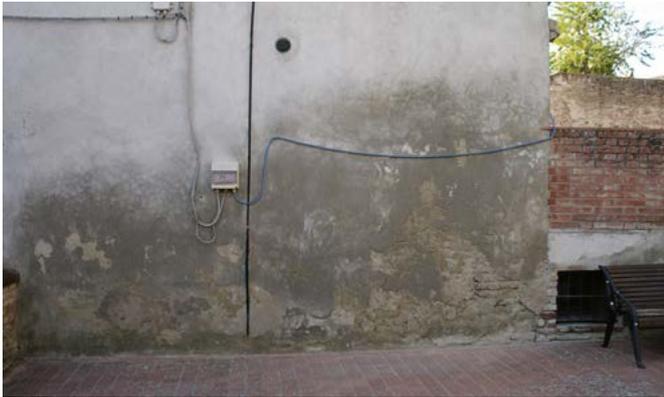
Change of color, reduction of the thermal insulation

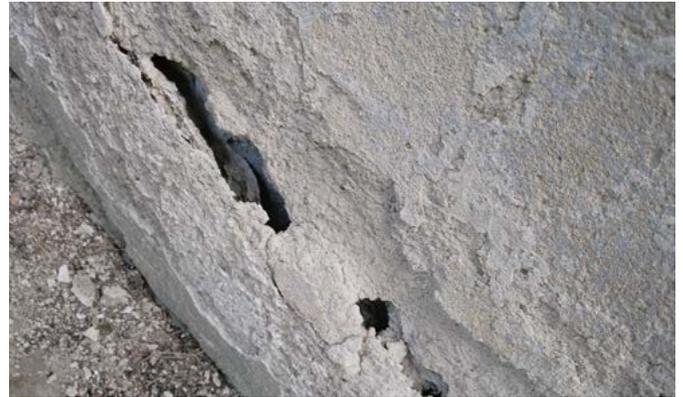
Damaged plaster

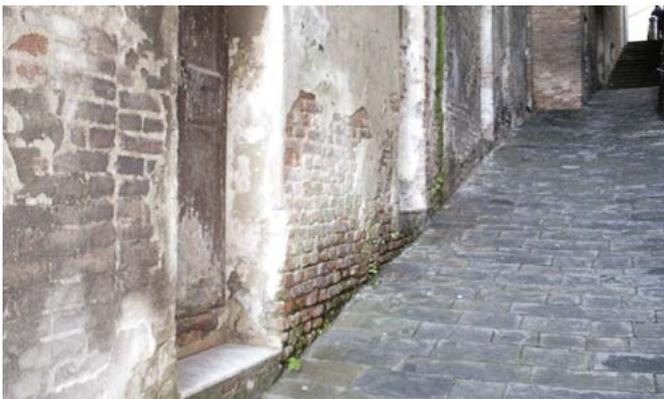
Destruction of render and mortar joints

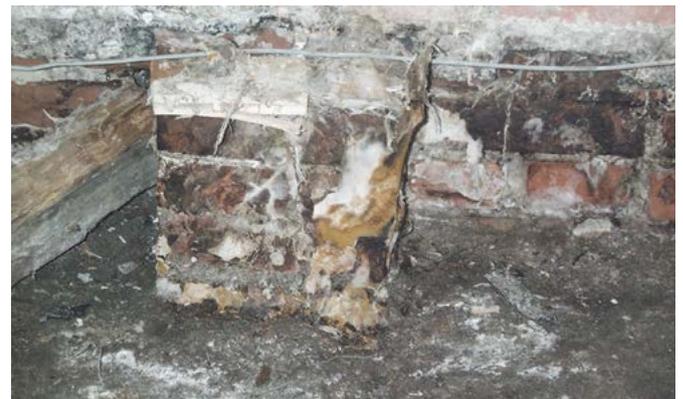
Development of mold and damage to the fabric of the structure

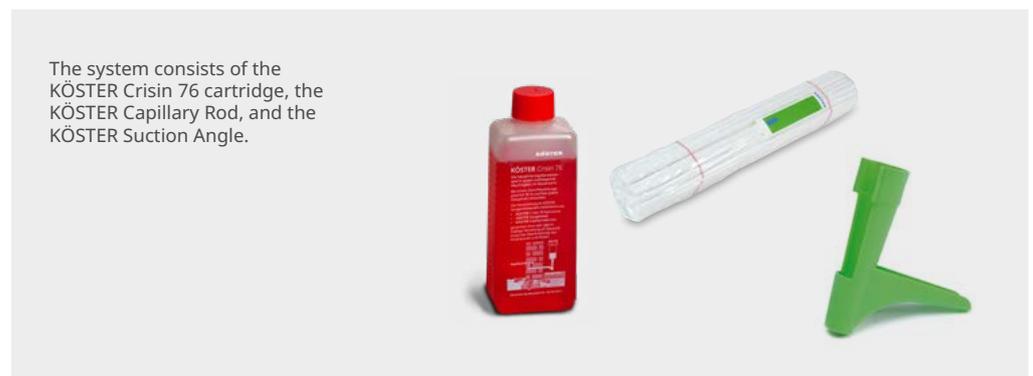
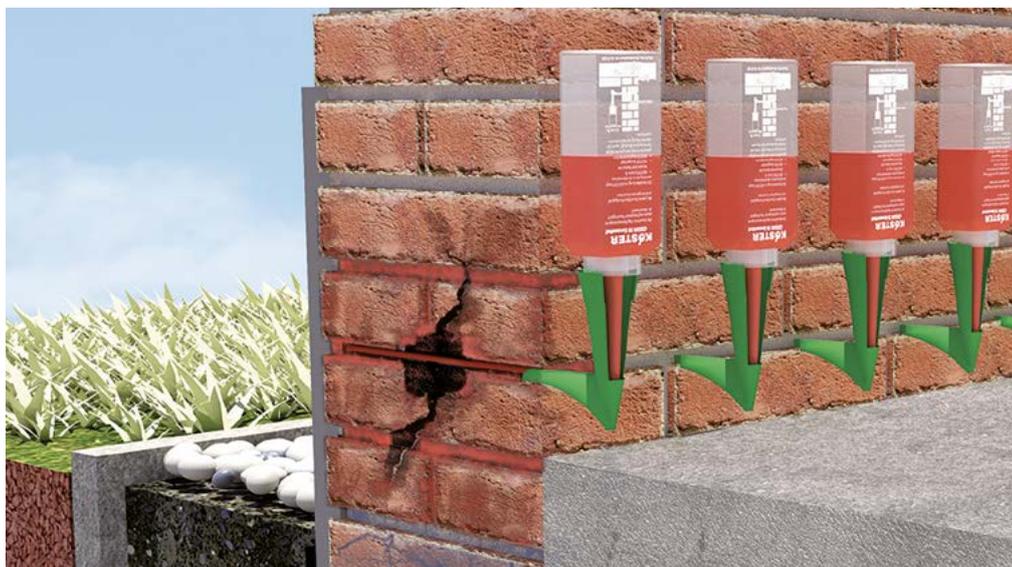
The patented KÖSTER Suction Angle Procedure:

Schematic representation.

The KÖSTER Capillary Rod acts like a wick, one end is inserted into the wall and the other end into the KÖSTER Suction Angle. From there, it draws the injection liquid into the wall. The KÖSTER Capillary Rod is available in lengths of 45 or 90 cm.

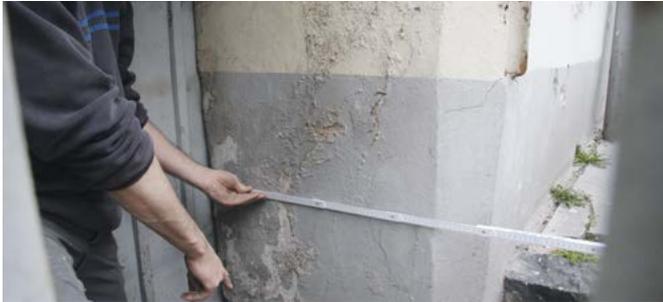
1 The salt and moisture contents are high in the masonry, the existing plaster is damaged.

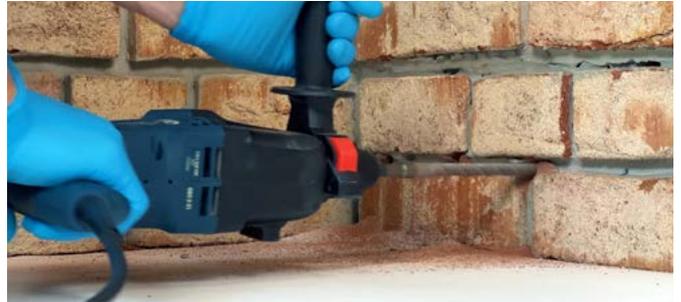
2 Boreholes are drilled into the inner wall with a distance of 10 cm from one another and depth of 40 cm (Wall thickness: 45 cm and 30 cm above grade).

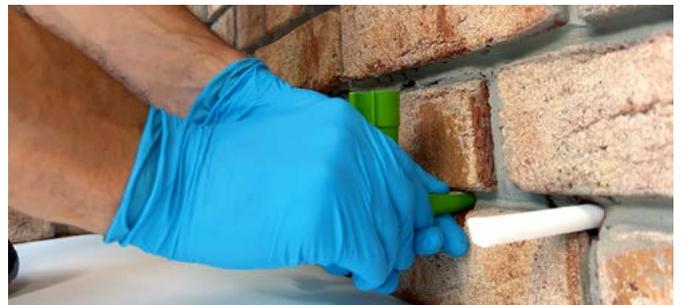
4 KÖSTER Capillary Rods are installed so that they protrude 7 cm from the borehole.

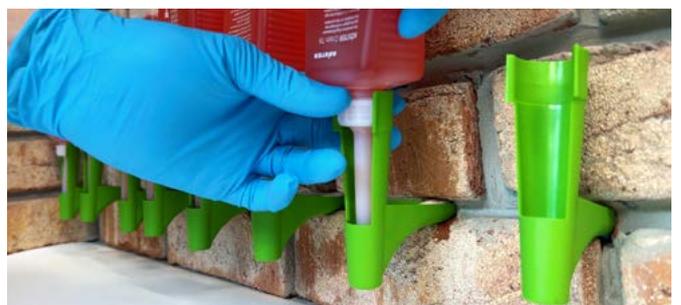
6 The KÖSTER Crisin 76 cartridges are then installed into the KÖSTER Suction Angle.

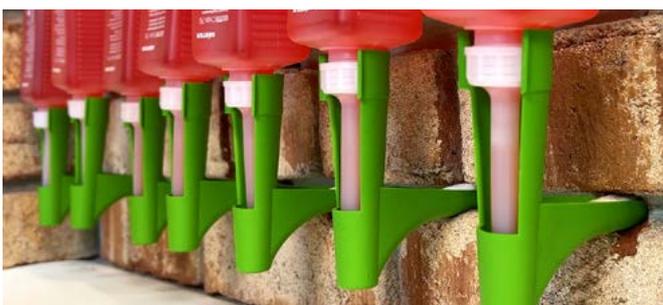
7 The nozzles of the cartridges sit directly on top of the capillary rod and allow the material to be soaked up.

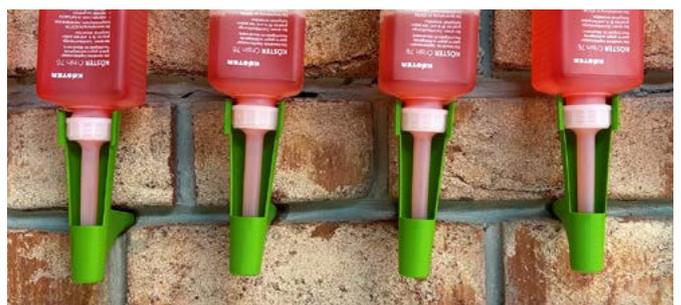
8 The pressureless injection of KÖSTER Crisin 76 into the masonry starts immediately after the installation of the cartridges.

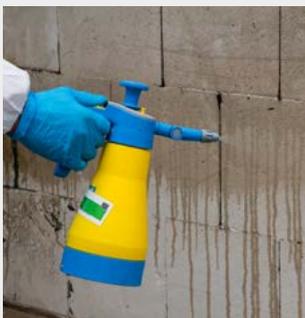
Remove old plaster. Spray KÖSTER Polysil TG 500 onto the surface to block salts and harden the substrate. Fill breakouts and holes with a KÖSTER Repair Mortar.

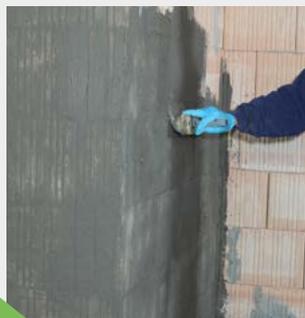
If negative side waterproofing is necessary, KÖSTER NB 1 Grey is applied in two layers.

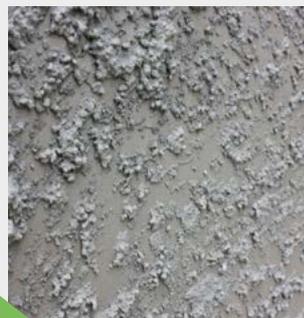
In the next step KÖSTER Restoration Plaster Key is applied to ensure the optimal adhesion of KÖSTER Restoration Plasters.

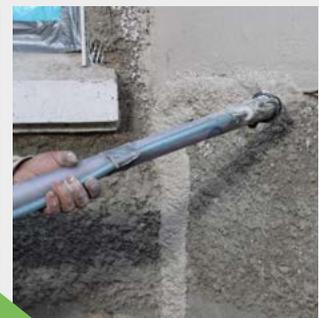
The KÖSTER Restoration Plaster is applied with a trowel or an appropriate mortar pump on the cured layer of KÖSTER Restoration Plaster Key. In the last step the surface is floated smooth.
